Exotic Plant Species Removal and Stream Habitat Maintenance Plan

2. Fish Barrier Removal

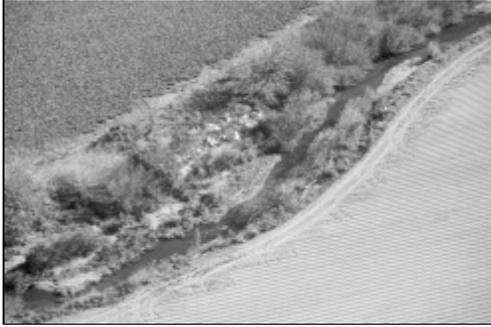
Figure 6. Photograph of Project Site SL-7-1R.

Problems: Problems associated with this site include degraded riparian vegetation, bank failure, erosion and subsequent sedimentation, and elevated water temperatures.

This site lies immediately downstream from the City of San Luis Obispo and receives high velocity flows during storm events. Degraded

riparian vegetation makes the banks and adjacent farmland vulnerable to erosion and flood scour. Soil eroded from the farm field reenters the creek just downstream and contributes to sedimentation. Resulting sedimentation degrades fisheries habitat by covering channel bed gravels used by anadromous fish for spawning.

Elevated water temperature is another problem on this site. Throughout the watershed, areas with degraded riparian vegetation leave the stream vulnerable to solar heating. The temperature remains elevated through the project site due to the lack of overhead canopy and shade. High water temperatures increase mortality rates of fish eggs and make it difficult for adult fish to extract dissolved oxygen from the water.

Project Description: This project will stabilize the outer bend of the Creek, possibly with the installation of a vegetation based stabilizing structure. This would decrease erosion and the amount of sediment entering the creek. The project will also include the addition of canopy cover trees and a riparian buffer strip composed of low growing understory species. The trees will shade the water and contribute to cooler water temperatures and the buffer strip will reduce the velocity of floodwaters and reduce soil erosion.

Some additional hydrologic analysis would be necessary to determine the bank stabilization methods. Where stabilization structures are used, creation of additional deep pool habitat through the use of structures such as logs and boulders that cause scouring of the channel bottom will be investigated. This reach of San Luis Obispo Creek is deficient in this type of habitat. Planning of fish habitat devices will be preceded by an investigation of water quality to determine the value of additional pool habitat at this location.

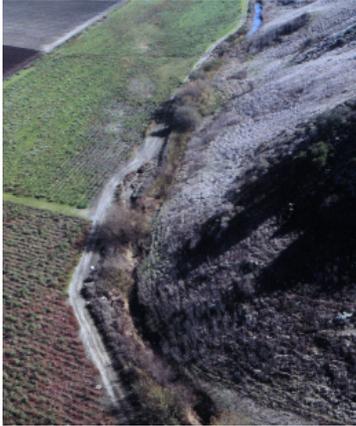
Figure 7. Photograph of project site EF-1-1R.

Problems: Problems on this site include degraded riparian vegetation and alteration of the natural creek channel. The result is an extremely unstable bank and stream channel that regularly causes severe erosion and sedimentation of San Luis Obispo Creek.

Project Description: The project plan is to correct the alignment of the channel and stabilize the banks with native vegetation.

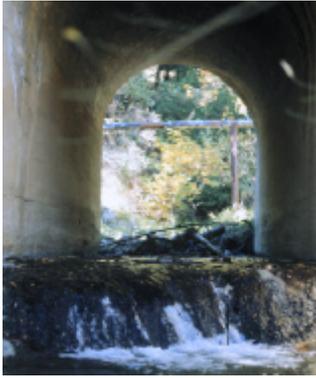
Figure 9. Photograph of San Luis Obispo Creek, Fish Barrier SL-16-1B.

Problem: This is a large concrete culvert that has a drop of approximately 2 feet at the downstream end, creating a velocity barrier at high flows and a sheeting depth barrier at low flow.

Project Description: A series of rock weirs will be constructed in the downstream channel to an elevation that will backwater the culvert.

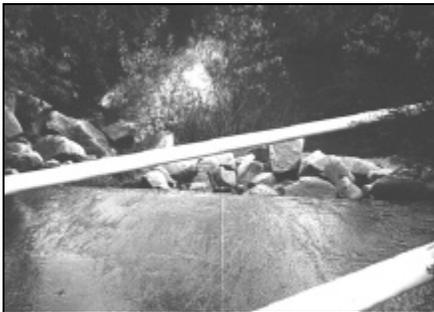
Figure 10. Photograph of Prefumo Creek, Fish Barrier PR-1-1B.

Problem: This culvert has a drop of approximately 3 to 4 feet at its outlet and poses an elevation barrier during high flows and a shallow water depth barrier during low flows. In addition, low flows travel under the riprap apron. This barrier inhibits fish access from San Luis Obispo Creek to the entire

Prefumo Creek drainage, that contains valuable trout habitat.

Project Description: A 4-step rock weir fishway will be constructed to step the water level to the bottom of the culvert. A concrete sill across the end of the culvert apron will also be installed.

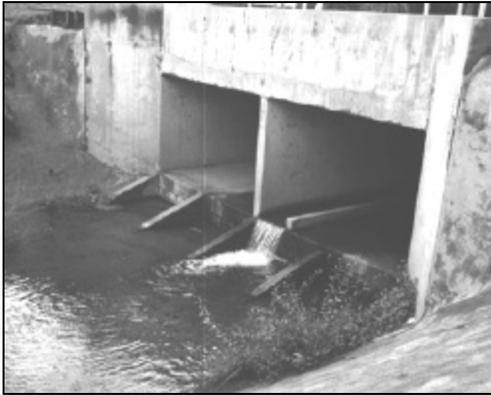
Figure 11. Photograph of Prefumo Creek, Fish Barrier PR-1-2B.

Problem: This barrier is a concrete box culvert that has a low flow channel constructed on the bottom through the use of concrete curbs. The culvert has a drop of approximately 3 to 4 feet at its outlet and poses an elevation barrier during high flows and a shallow water depth barrier during low flows.

Project Description: Fish passage improvement gained from the curbs appears to be marginal. Project plans are to construct a 3-step rock weir fishway to raise water to the level of the culvert floor. Adding baffles to the culvert floor could increase the efficiency of passage through the culvert, but would also impact its hydraulic capacity.

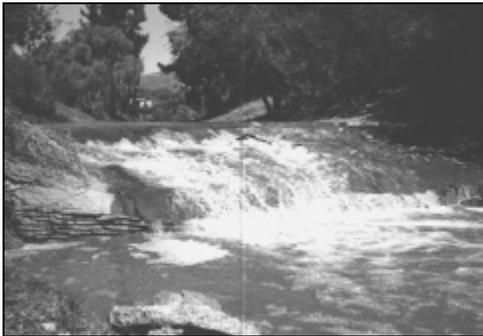
Figure 12. Photograph of Prefumo Creek, Fish Barrier PR-1-3B.

Problem: A 5-foot high grouted rock dam constructed to protect a sewer line poses an elevation barrier to fish passage. Fifty feet downstream is an armored section of the stream bed used as an agricultural equipment crossing.

Project Description: A 5-step rock weir fishway along with minor modifications of the dam to concentrate flow will be constructed. Maintaining the agricultural equipment crossing may also be included by installing a hard surface crossing 1-foot thick by 12-feet wide in the lowest weir.
